## Bridge deck (Romania)

| <b>Place/Time</b> | Bucharest – Romania, October 2010 |

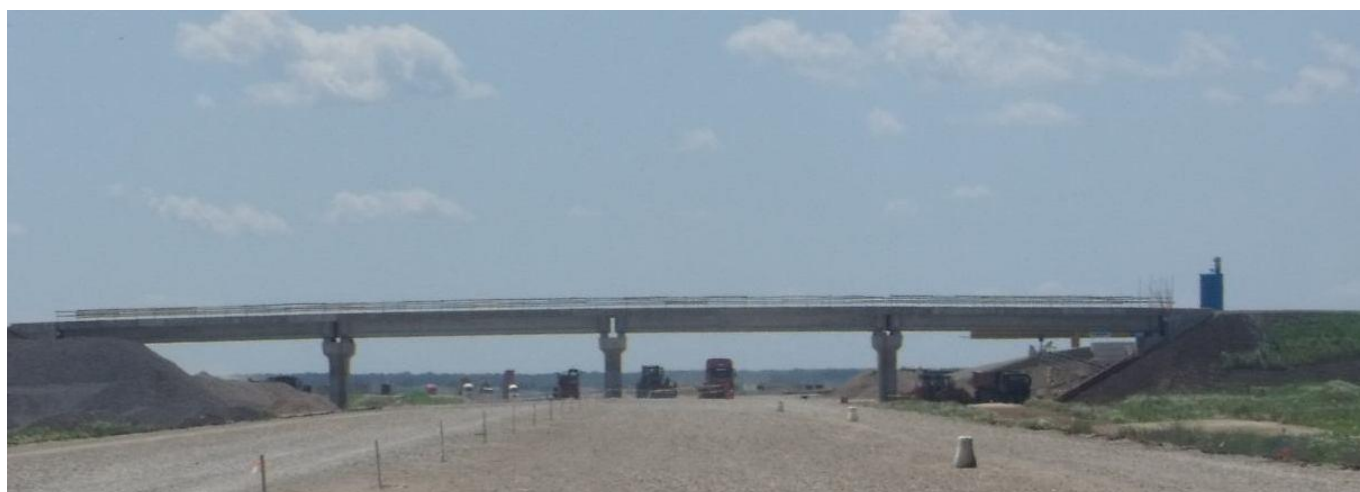
| <b>Application</b> | <p>Krystaline Add1 was added to the concrete as the only waterproofing and protection system for the deck surfaces. The product was added at 1 kg per m<sup>3</sup> on site and mixed for 10 minutes prior to concrete placement.</p> <p>Given the high dust and dry conditions at the time of application the surface areas were protected with wet burlap during the curing process.</p> |
